## Property Condition Report

**Case Number:** 094-543992

**Full Address:** 3986 Campfire Way  
Casselberry, FL 32707

**Inspection Date:** 08-12-2010

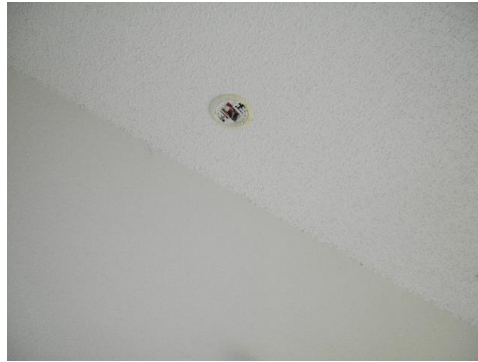
Checkpoint	Rating	Comment
Cabinets:	S	
Ceilings:	S	
Closets:	MR	There is graffiti on the closet doors.
Countertops:	S	
Interior Debris:	S	
Detectors:	MR	There are missing smoke detectors.
Door Hardware:	S	
Doors:	MR	There are missing and damaged interior doors.
Dryer Vent:	S	
Floor:	MR	There are damaged carpets.
Mold:	NV	
Railings:	NA	
Stairwells:	NA	
Steps:	NA	
Walls:	MR	There are damaged walls.
Windows:	S

14. Missing Smoke Detector

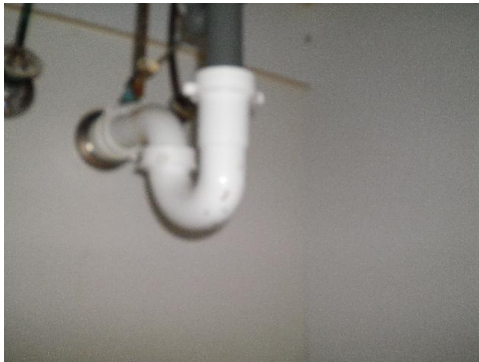
16. Secured Water

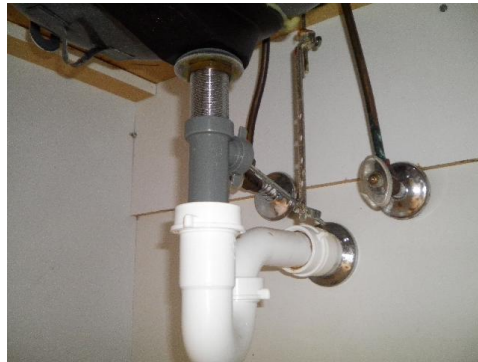
17. Secured Water

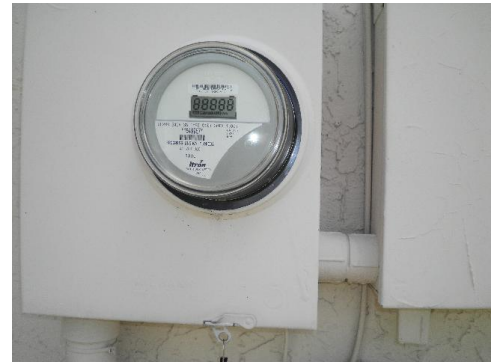
45. Meter

Checkpoint	Rating	Comment
Appliance Wiring:	S	
Bath GFCI:	S	
Breaker Cond.:	S	
Exterior GFCI:	S	
Exterior Wiring:	S	
Ground/Bonding:	NV	
HVAC Wiring:	S	
Interior Wiring:	S	
Kitchen GFCI:	S	
Lighting Fixtures:	S	
Panel Box:	S	
Rec. Location:	S	
Service Attach:	S	
Service Meter:	S	The electric meter was present and the meter seal was intact.
Sub Panel Box:	S
